**Docket No. 217 – Development and Management Plan Inspection**

**Date:** May 13, 2005

**Location:** 115 kV Underground Route – Gallows Hill Road

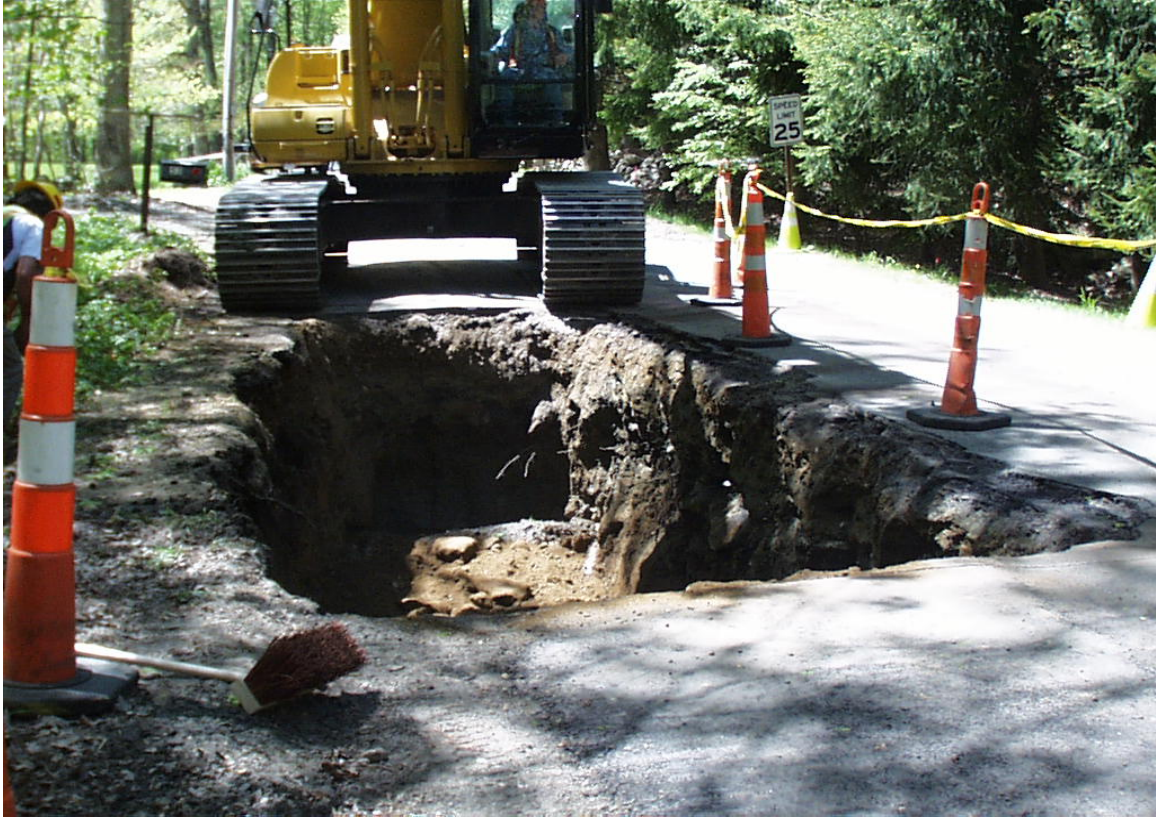
Gallows Hill Road: View of a hole for a vault being dug and then backfilled. All extraneous excavate is being trucked to the Redding town yard. 5/13/05

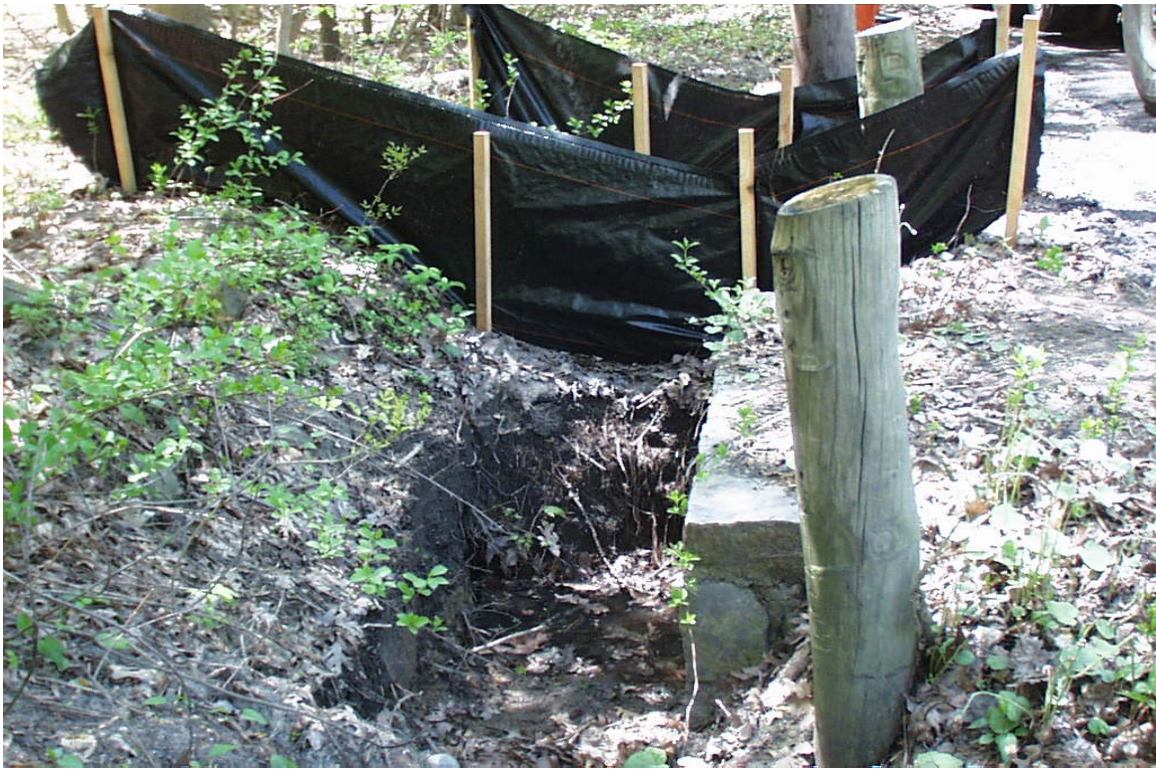
- Several silt fence check dams have been placed in the existing country drainage swales along the roadway to protect the inlets from sedimentation. 5/13/05	- None at this time. Continue to monitor and maintain and repair controls as necessary. 5/13/05

Silt fence and haybale check dams have been installed in country drainage swales and inlets. 5/13/05

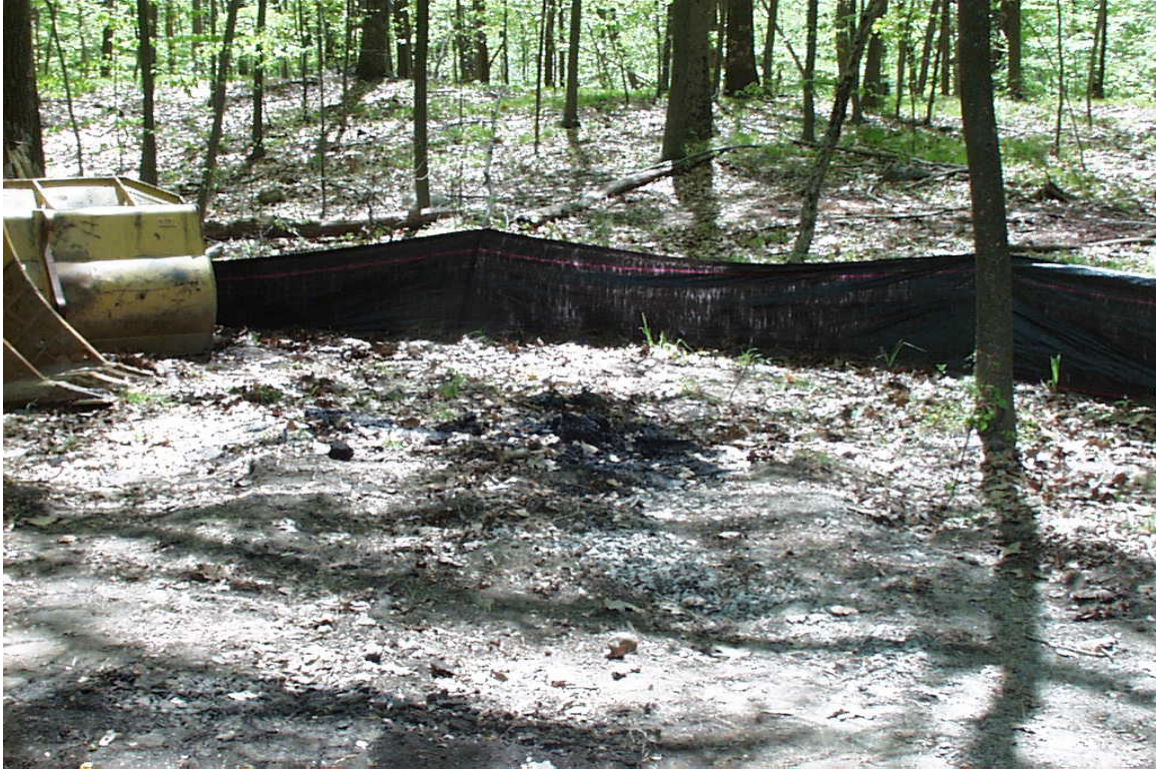
Staging and parking areas have been set up along the roadway and silt fence is used when wetlands are in the vicinity. 5/13/05

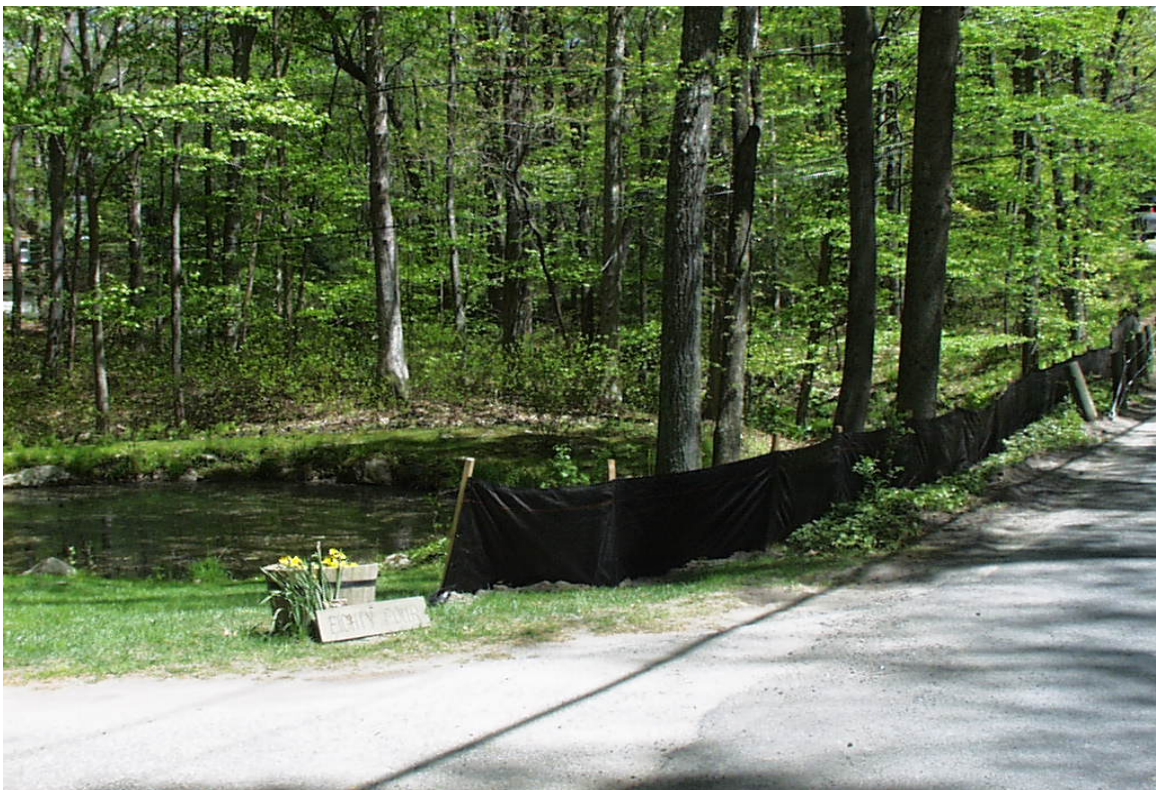
Silt fence is installed well when wetlands are adjacent to the roadway work. 5/13/05

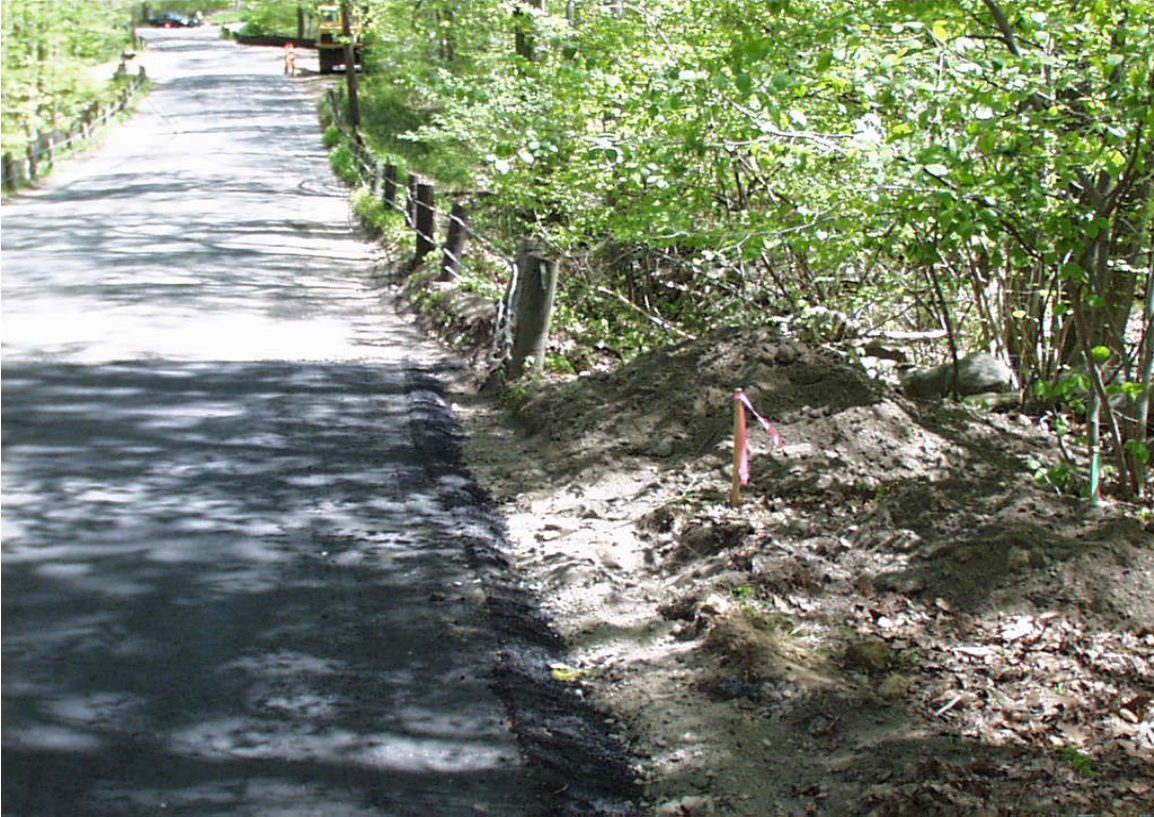
Areas of Inspection	Observation	Recommended Action
Erosion and Sediment Controls continued	<ul style="list-style-type: none"> <li>- Stockpiles are not currently present for the most part. All excavated material is being trucked to the Redding town yard and stored appropriately 5/13/05</li> <li>- One small pile of soil was noted at the road edge near a completed vault hole. 5/13/05</li> </ul>	<ul style="list-style-type: none"> <li>- If stockpiles become necessary on site, a haybale line should be installed downgradient of the pile.</li> <li>- This pile should be removed before the next predicted rainfall. 5/13/05</li> </ul>
Adjacent Wetlands and Waterways	-None of the wetland resource areas adjacent to the roadway work were affected by the activities. No sedimentation or turbidity was noted. 5/13/05	-None at this time. Continue to monitor.
Staging and Parking Areas	- A pull-off area on the side of the roadway has been designated as a staging and machinery parking area. It was enclosed by silt fence and well maintained. 5/13/05	- A small pile of asphalt was noted here and this will be cleaned up when the area is restored following the work. No other recommendations at this time. 5/13/05

A small pile of leftover soil was placed off the road near a completed vault hole. It should be removed before the next rainstorm. 5/13/05
